**RADIOLOGICAL CHARACTERIZATION REPORT FOR
FUSRAP PROPERTIES IN THE ST. LOUIS, MISSOURI, AREA**

VOLUME I

MARCH 1990

**K. C. Noey
C. M. Sekula
Bechtel National, Inc.
Oak Ridge, Tennessee**

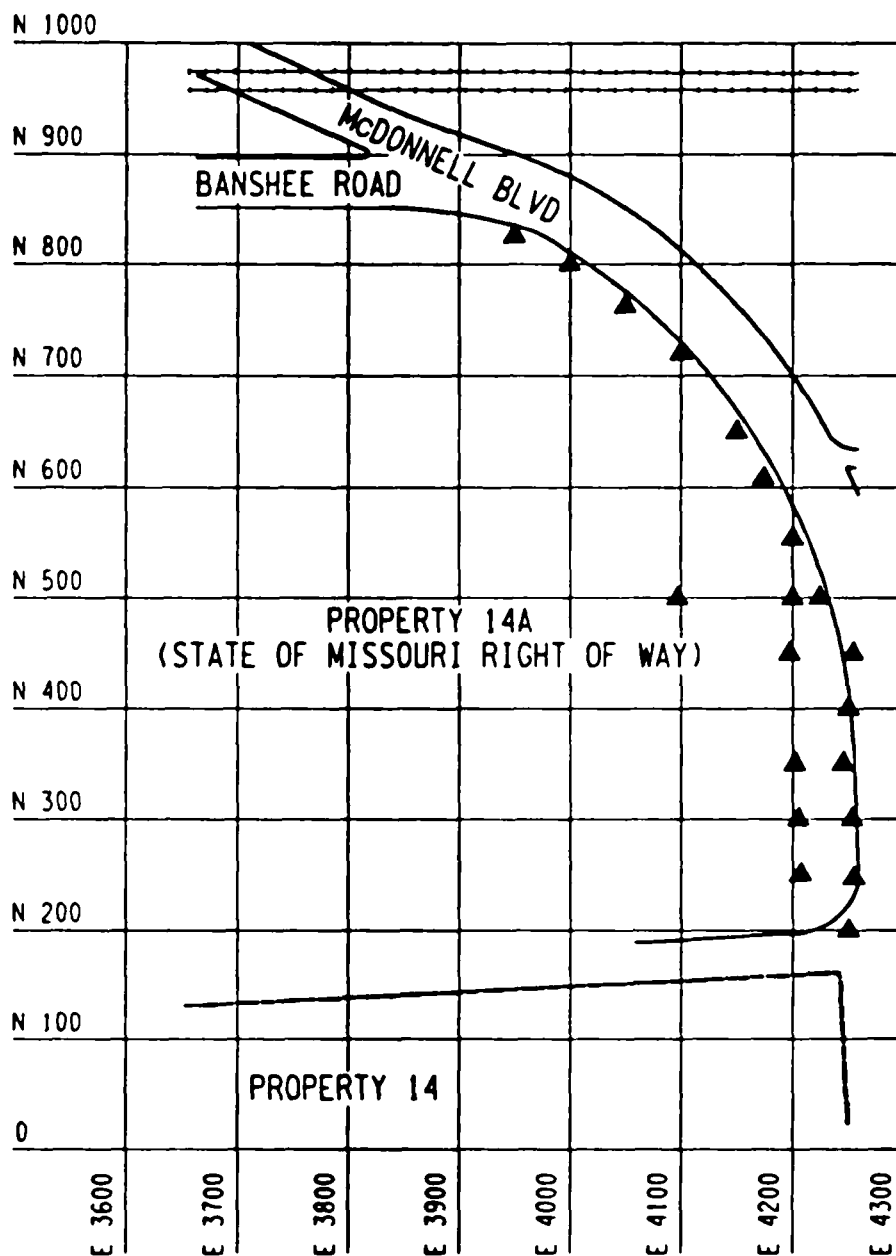
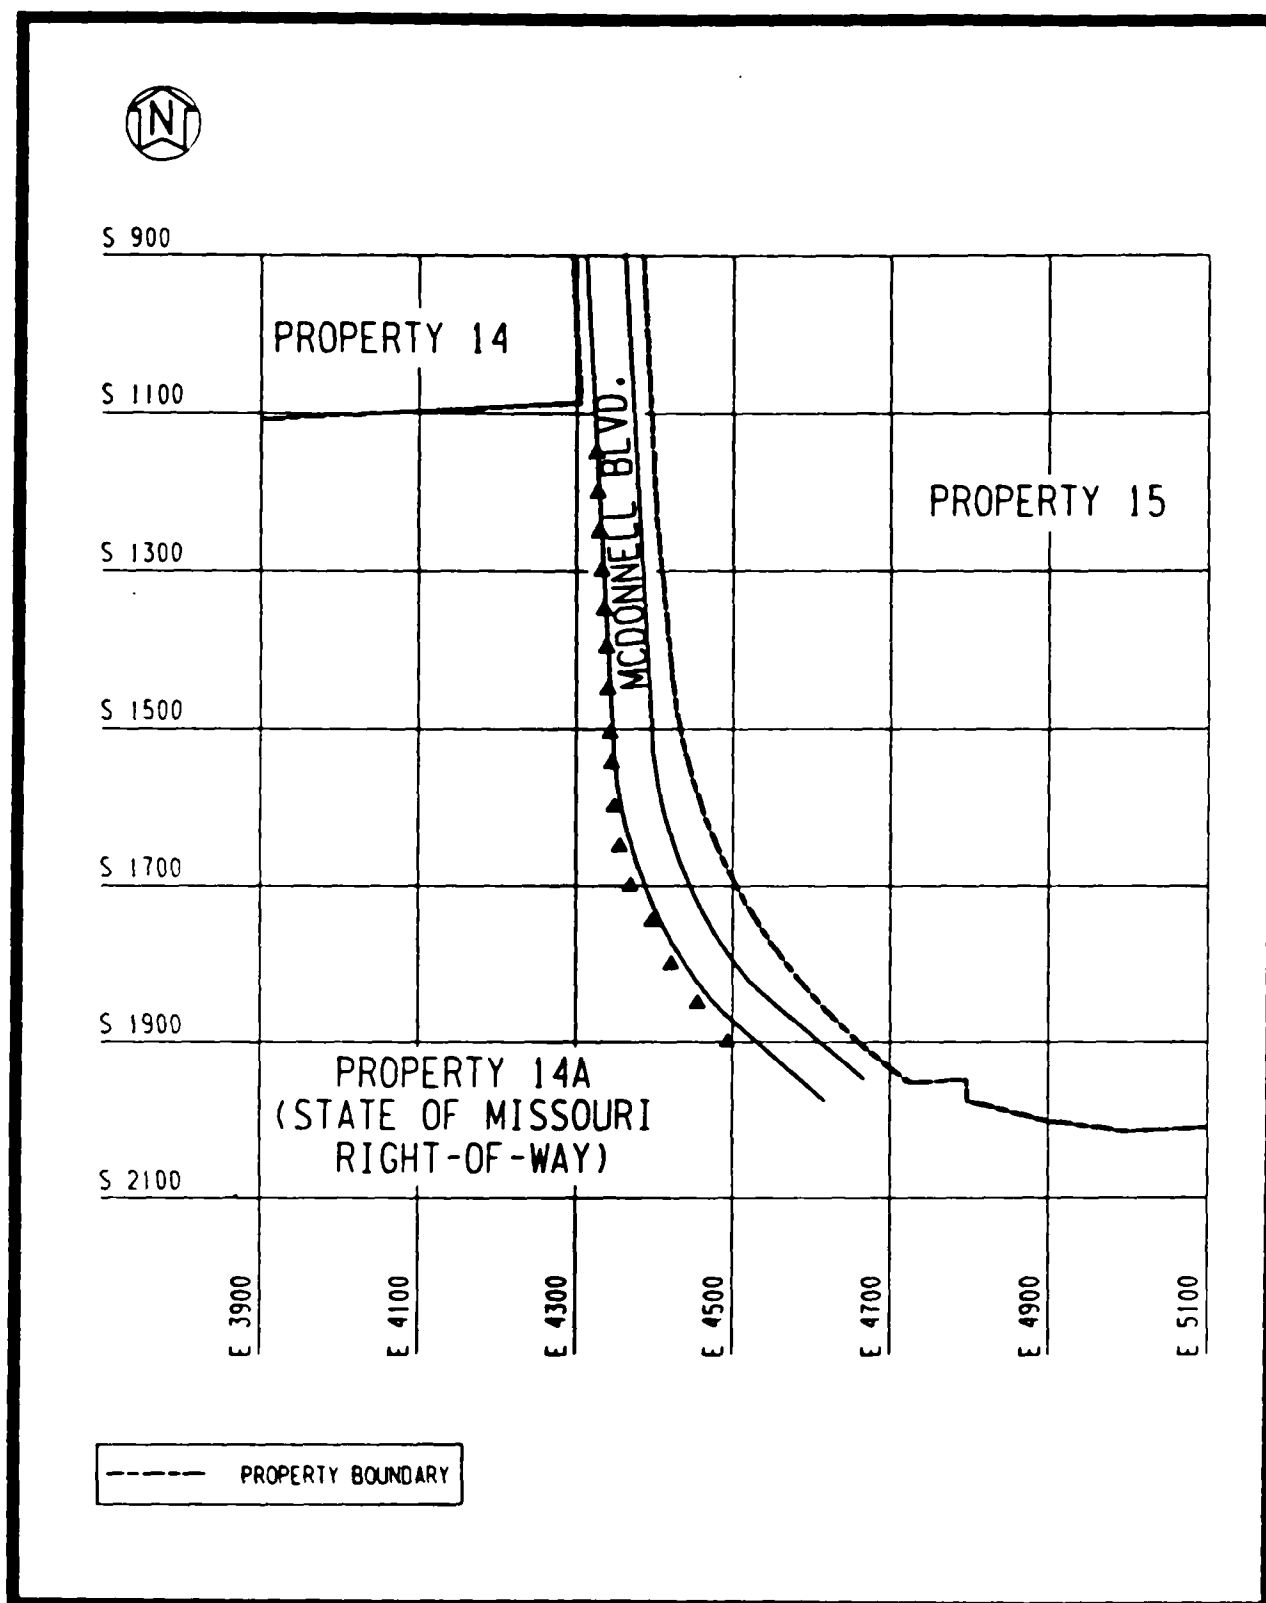
FIGURE 5-35 SOIL SAMPLING LOCATIONS FOR RADIOLOGICAL CHARACTERIZATION OF HAUL ROADS VICINITY PROPERTY 14A

Soil sampling locations at Property 14A are shown in Figure 5-35. Analytical results for soil (Table 5-22) revealed elevated thorium-230 concentrations at nine locations. Concentrations of thorium-230 ranged from less than 0.4 to 36 pCi/g. Further soil sampling is required to establish the boundaries of radioactive contamination on Property 14A; this sampling will take place before remedial action begins.

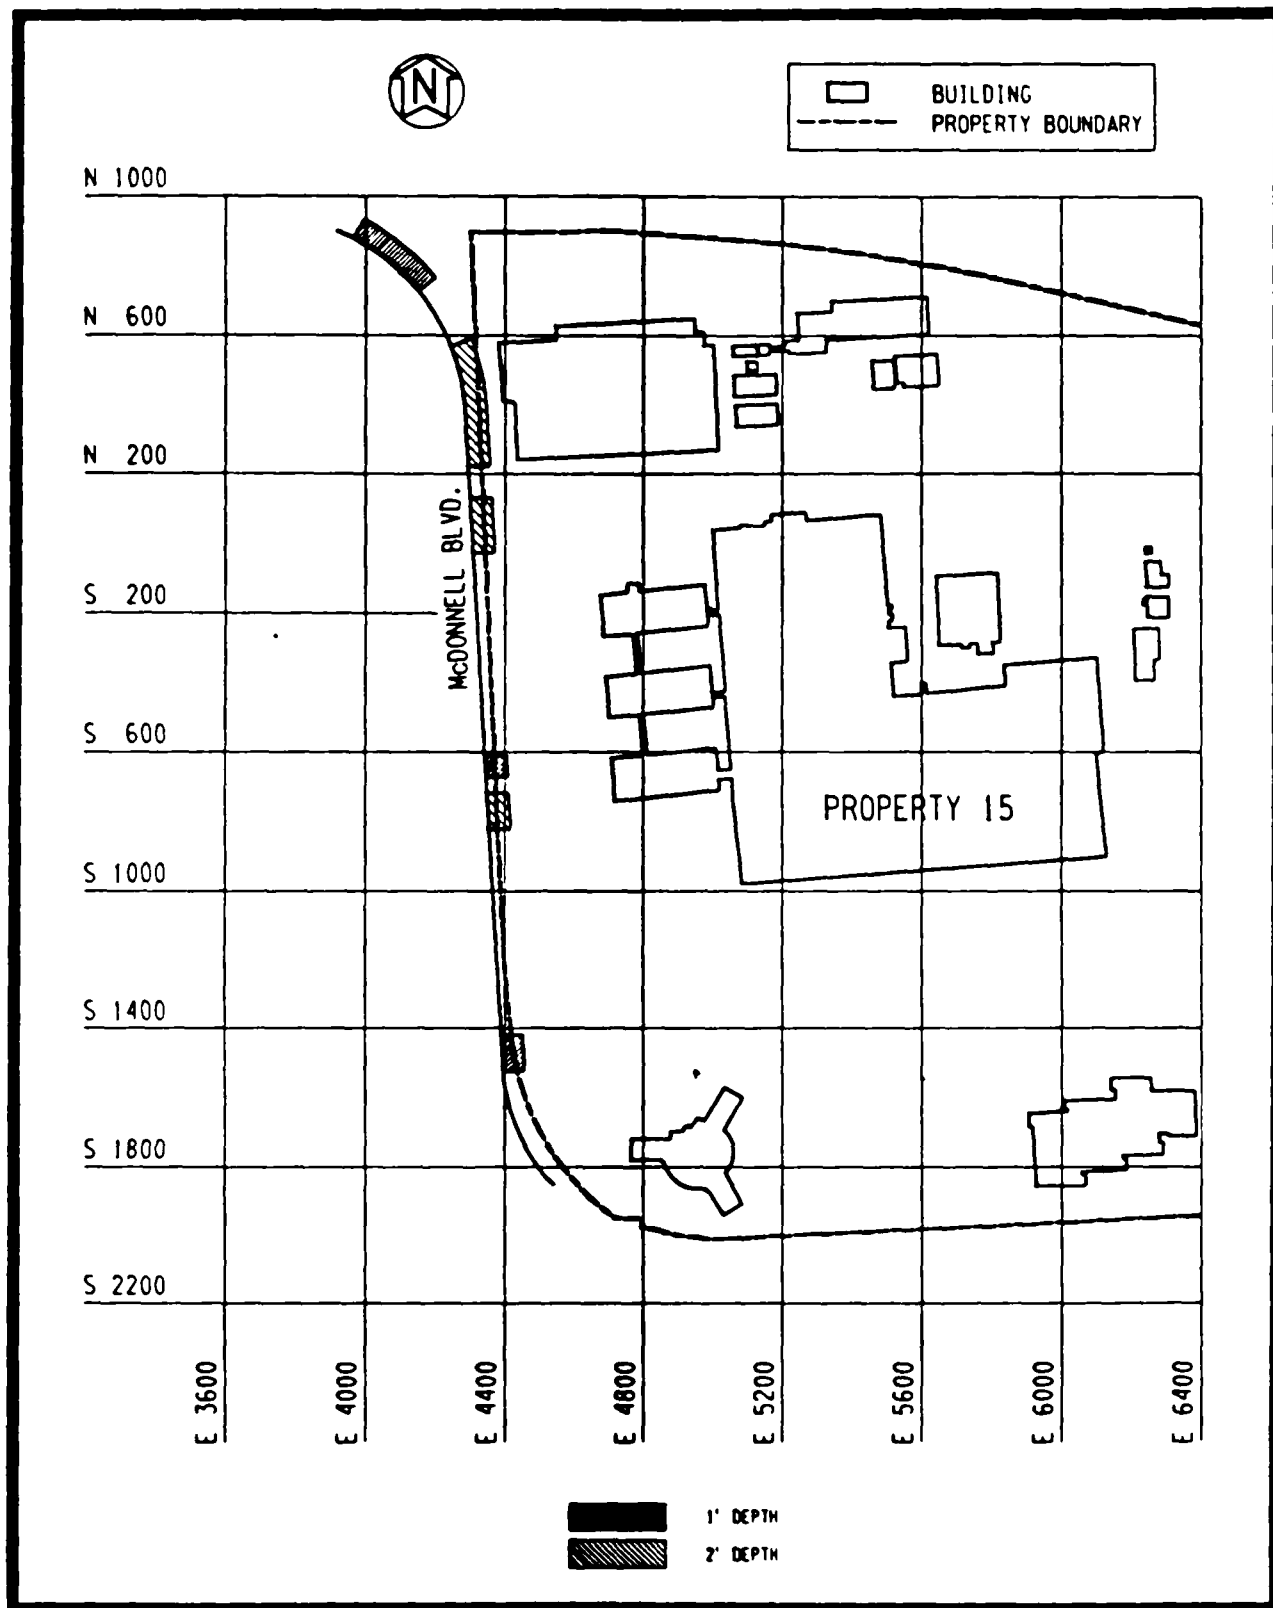
FIGURE 5-37 AREAS AND DEPTHS OF RADIOACTIVE CONTAMINATION
AT HAUL ROADS VICINITY PROPERTY 15

Property 15 is located on McDonnell Boulevard, southeast of SLAPS. Locations from which samples were collected and analyzed are shown in Figure 5-36. Analytical results for soil (Table 5-23) revealed 19 areas with elevated concentrations of thorium-230, which ranged from less than 0.6 to 460 pCi/g. Areas and depths of radiological contamination at Property 15 are shown in Figure 5-37.

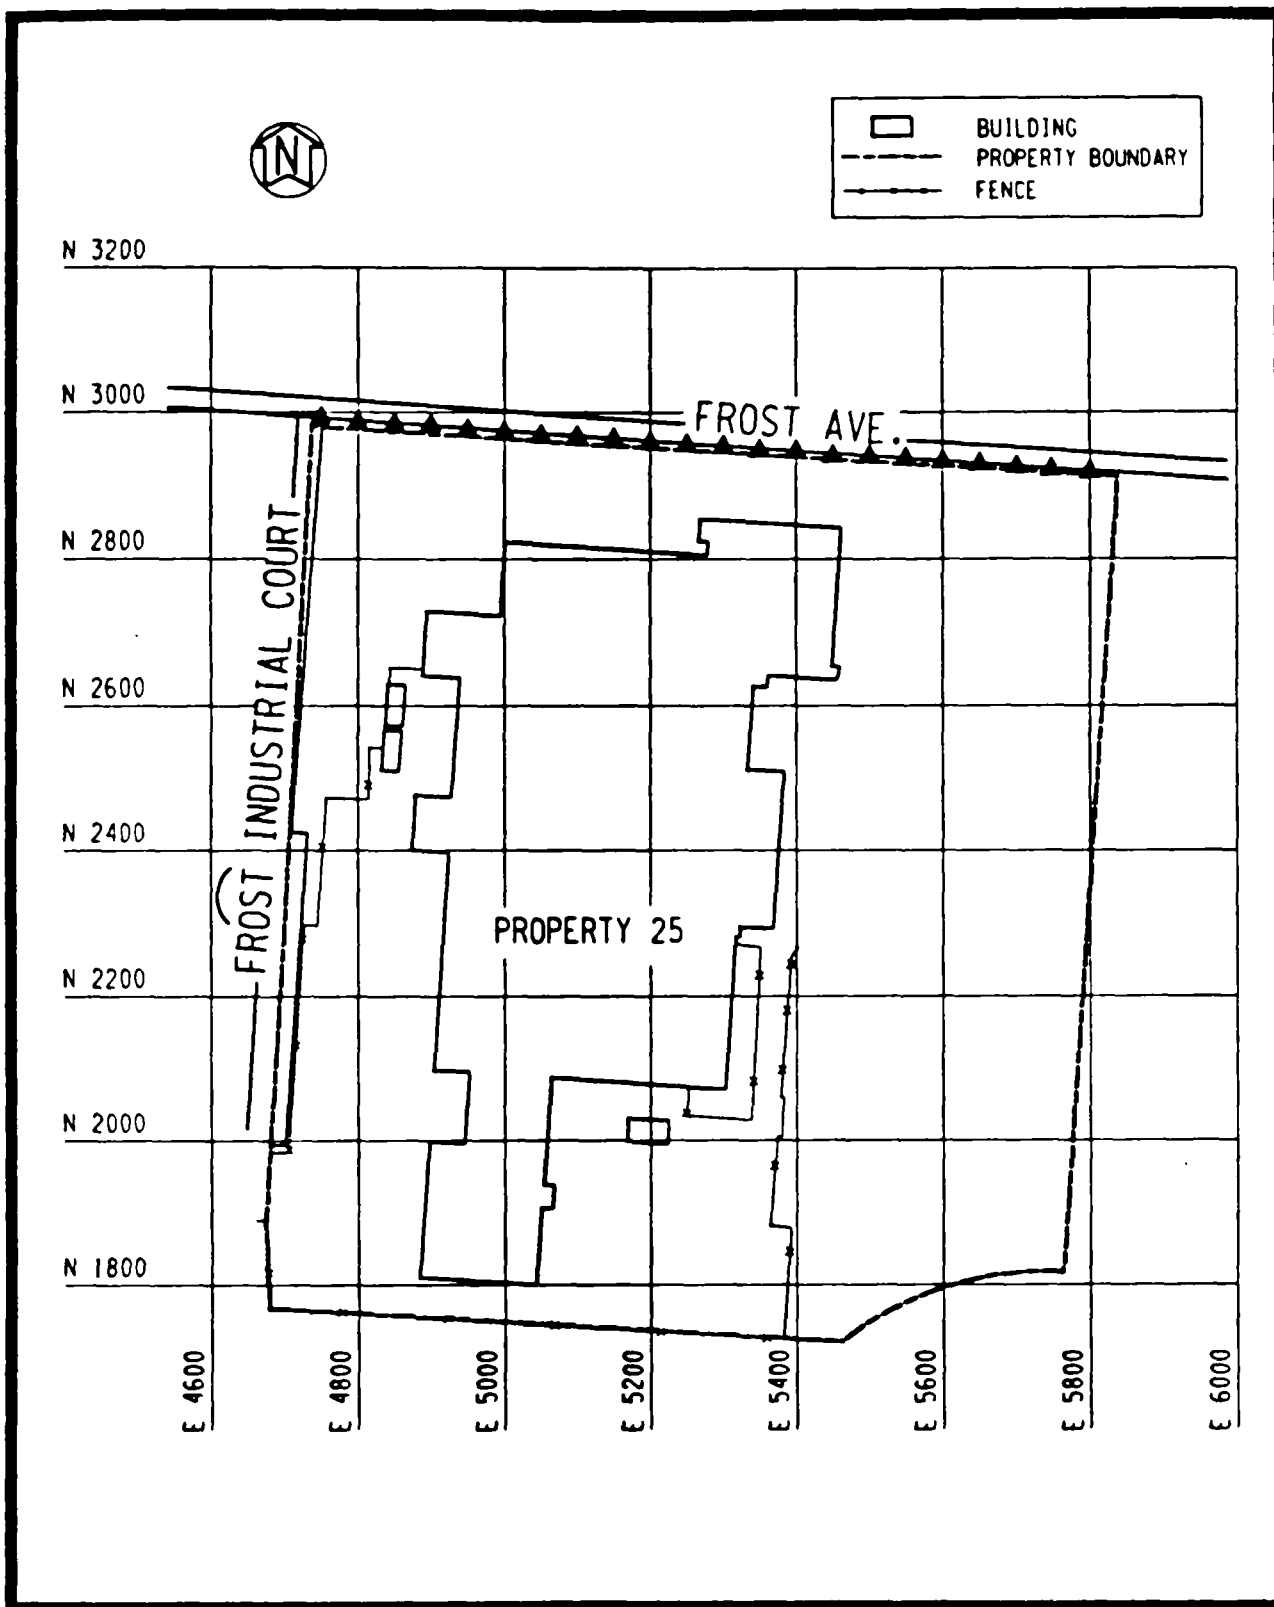
FIGURE 5-54 SOIL SAMPLING LOCATIONS FOR RADIOLOGICAL CHARACTERIZATION OF HAUL ROADS VICINITY PROPERTY 25

Property 25 is located on the south side of Frost Avenue. Locations from which samples were collected and analyzed from the Frost Avenue right-of-way bordering Property 25 are shown in Figure 5-54. Analytical results for soil (Table 5-33) revealed no areas exhibiting elevated levels of thorium-230. Thorium-230 concentrations ranged from 1 to 4.8 pCi/g.

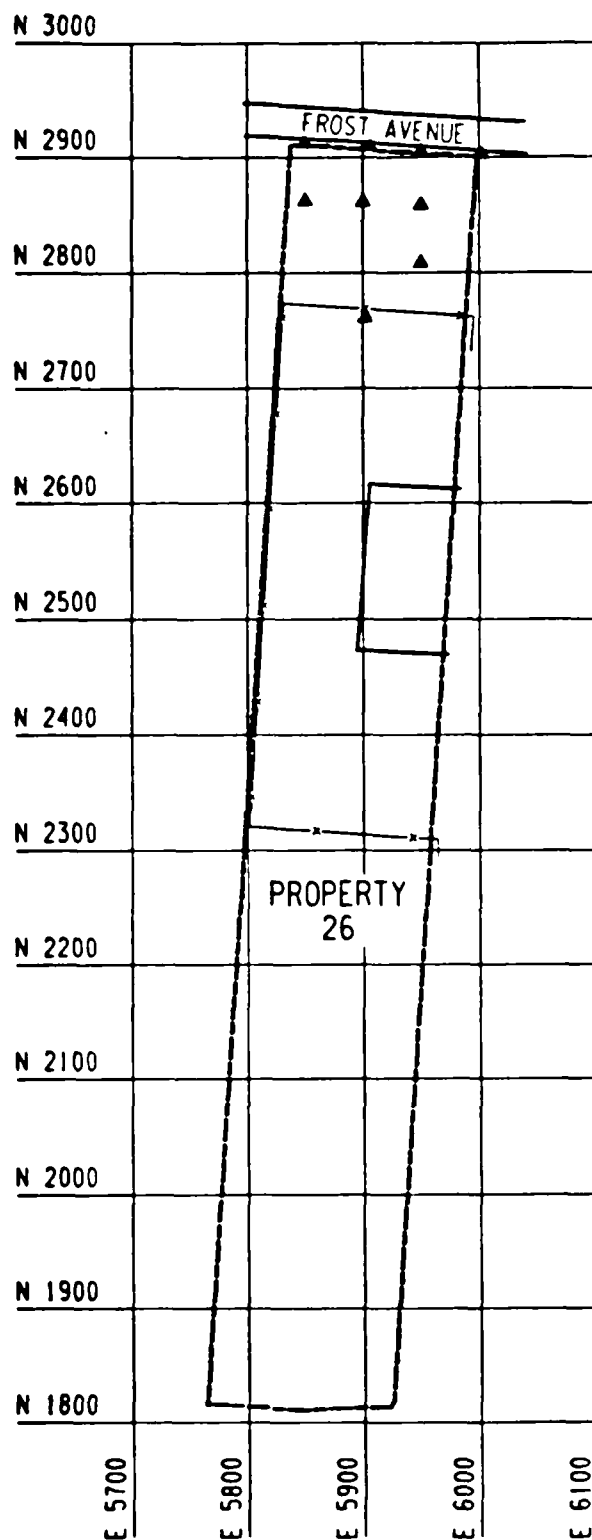
FIGURE 5-55 SOIL SAMPLING LOCATIONS FOR RADIOLOGICAL CHARACTERIZATION OF HAUL ROADS VICINITY PROPERTY 26

Property 26 is located on Frost Avenue. Locations from which soil samples were collected and analyzed are shown in Figure 5-55. Analytical results for soil (Table 5-34) revealed two sampling locations with elevated concentrations of thorium-230, which ranged from 1.4 to 6.9 pCi/g. Areas and depths of radioactive contamination at Property 26 are shown in Figure 5-56.

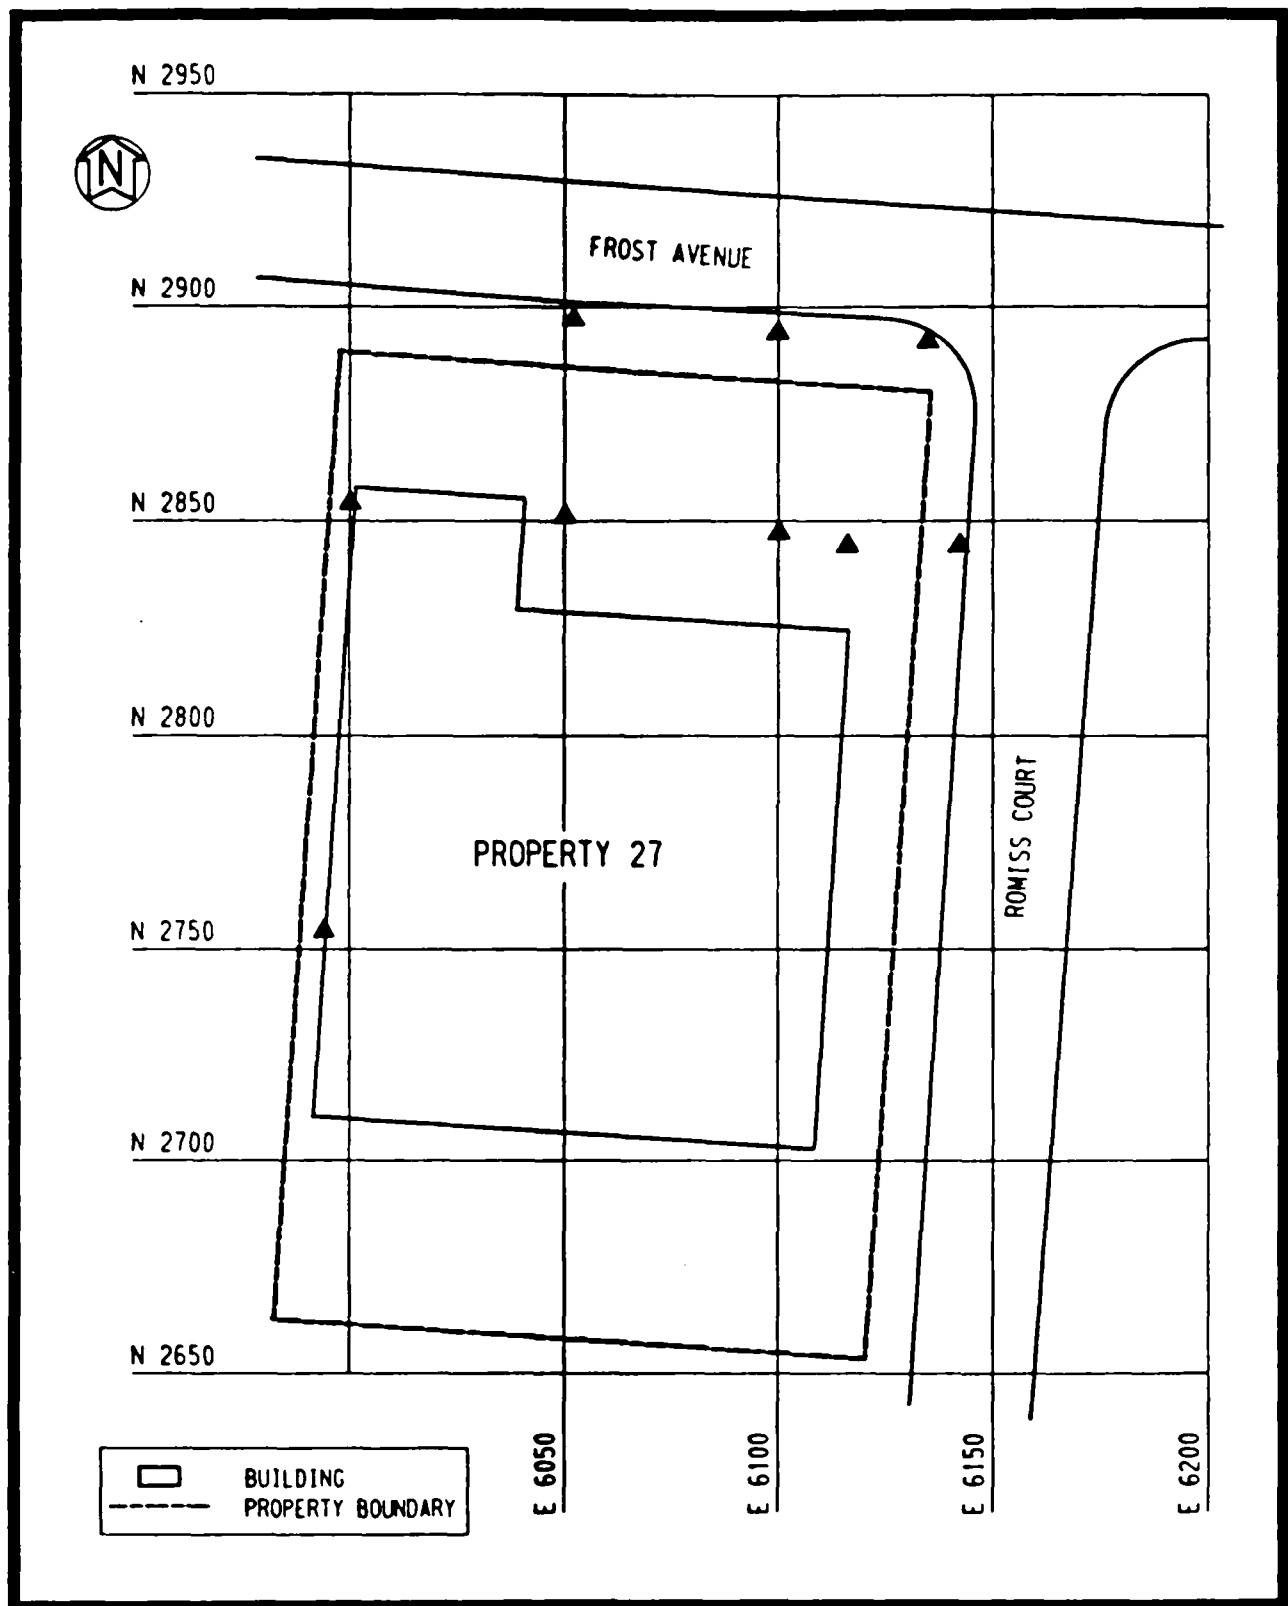
FIGURE 5-57 SOIL SAMPLING LOCATIONS FOR RADIOLOGICAL CHARACTERIZATION OF HAUL ROADS VICINITY PROPERTY 27

Property 27 is located on the west corner at the intersection of Frost Avenue and Romiss Court. Locations from which soil samples were collected and analyzed are shown in Figure 5-57. Analytical results for soil (Table 5-35) revealed two areas with elevated concentrations of thorium-230, which ranged from 1.4 to 8.1 pCi/g. Areas and depths of radioactive contamination at Property 27 are shown in Figure 5-58. The area of contamination shown in Figure 5-58 is a conservative estimate of contamination boundaries. Before remedial action begins, additional soil samples will be collected and analyzed from this property to more accurately define contamination boundaries.

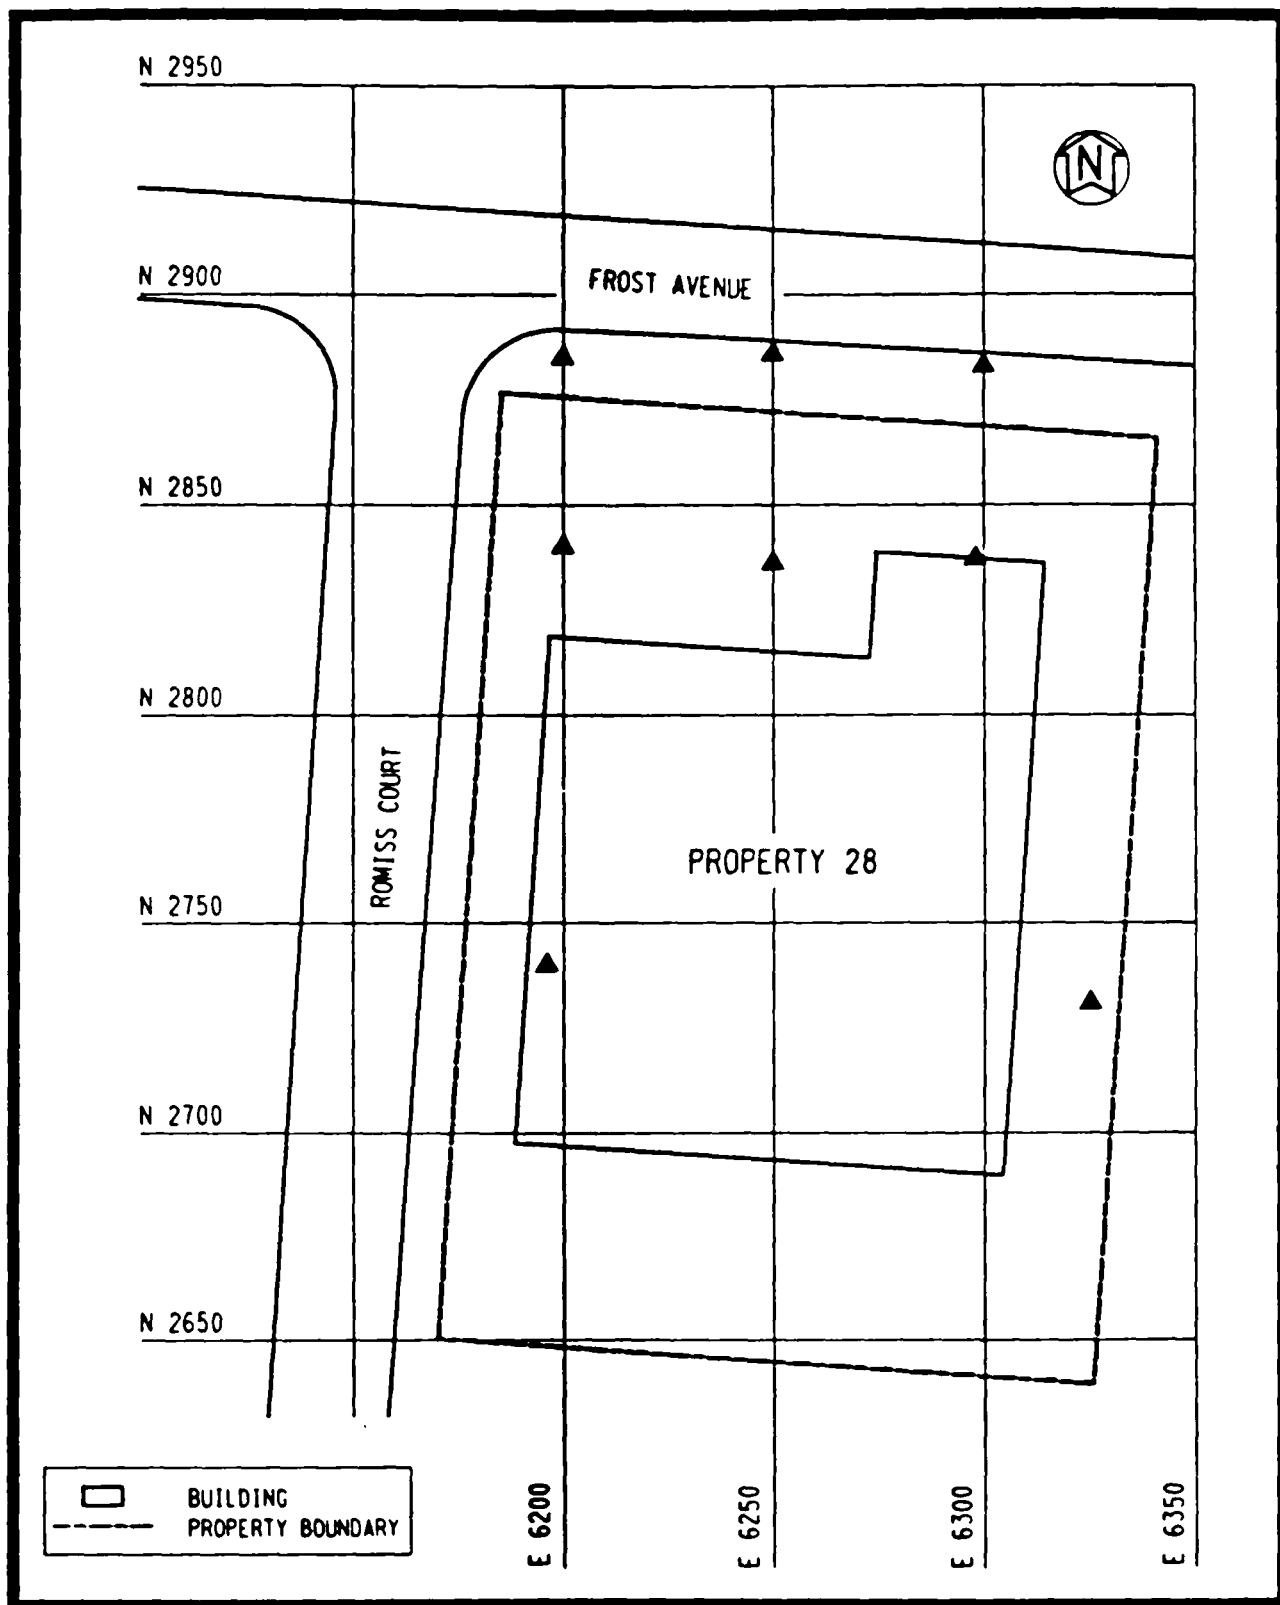
FIGURE 5-59 SOIL SAMPLING LOCATIONS FOR RADIOLOGICAL CHARACTERIZATION OF HAUL ROADS VICINITY PROPERTY 28

Property 28 is located on the east corner at the intersection of Frost Avenue and Romiss Court. Locations from which soil samples were collected and analyzed are shown in Figure 5-59. Analytical results for soil (Table 5-36) revealed no areas exhibiting elevated levels of thorium-230. Thorium-230 concentrations ranged from 1.5 to 4.6 pCi/g.

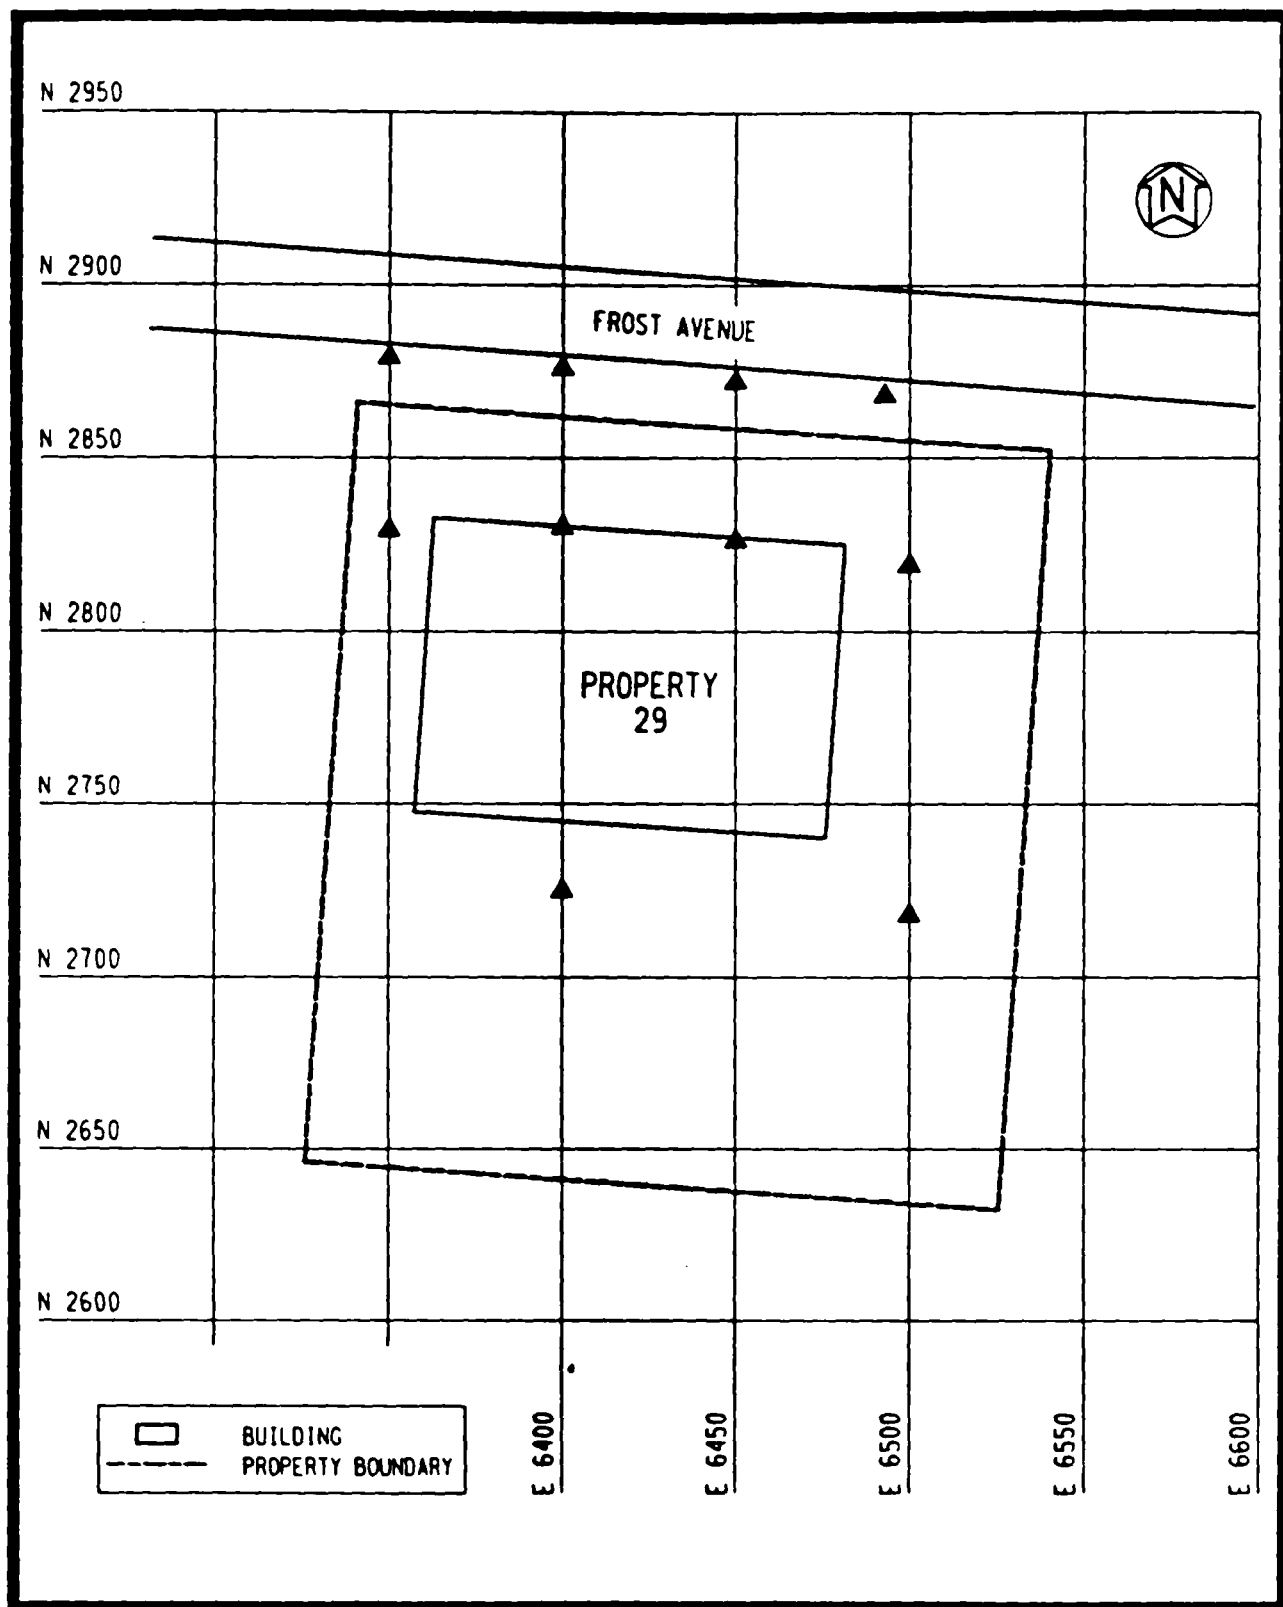
FIGURE 5-60 SOIL SAMPLING LOCATIONS FOR RADIOLOGICAL CHARACTERIZATION OF HAUL ROADS VICINITY PROPERTY 29

Property 29 is located on Frost Avenue. Locations from which soil samples were collected and analyzed are shown in Figure 5-60. None of the soil samples analyzed exhibited elevated thorium-230 concentrations, which ranged from 0.7 to 3.2 pCi/g. Analytical results for soil are provided in Table 5-37.

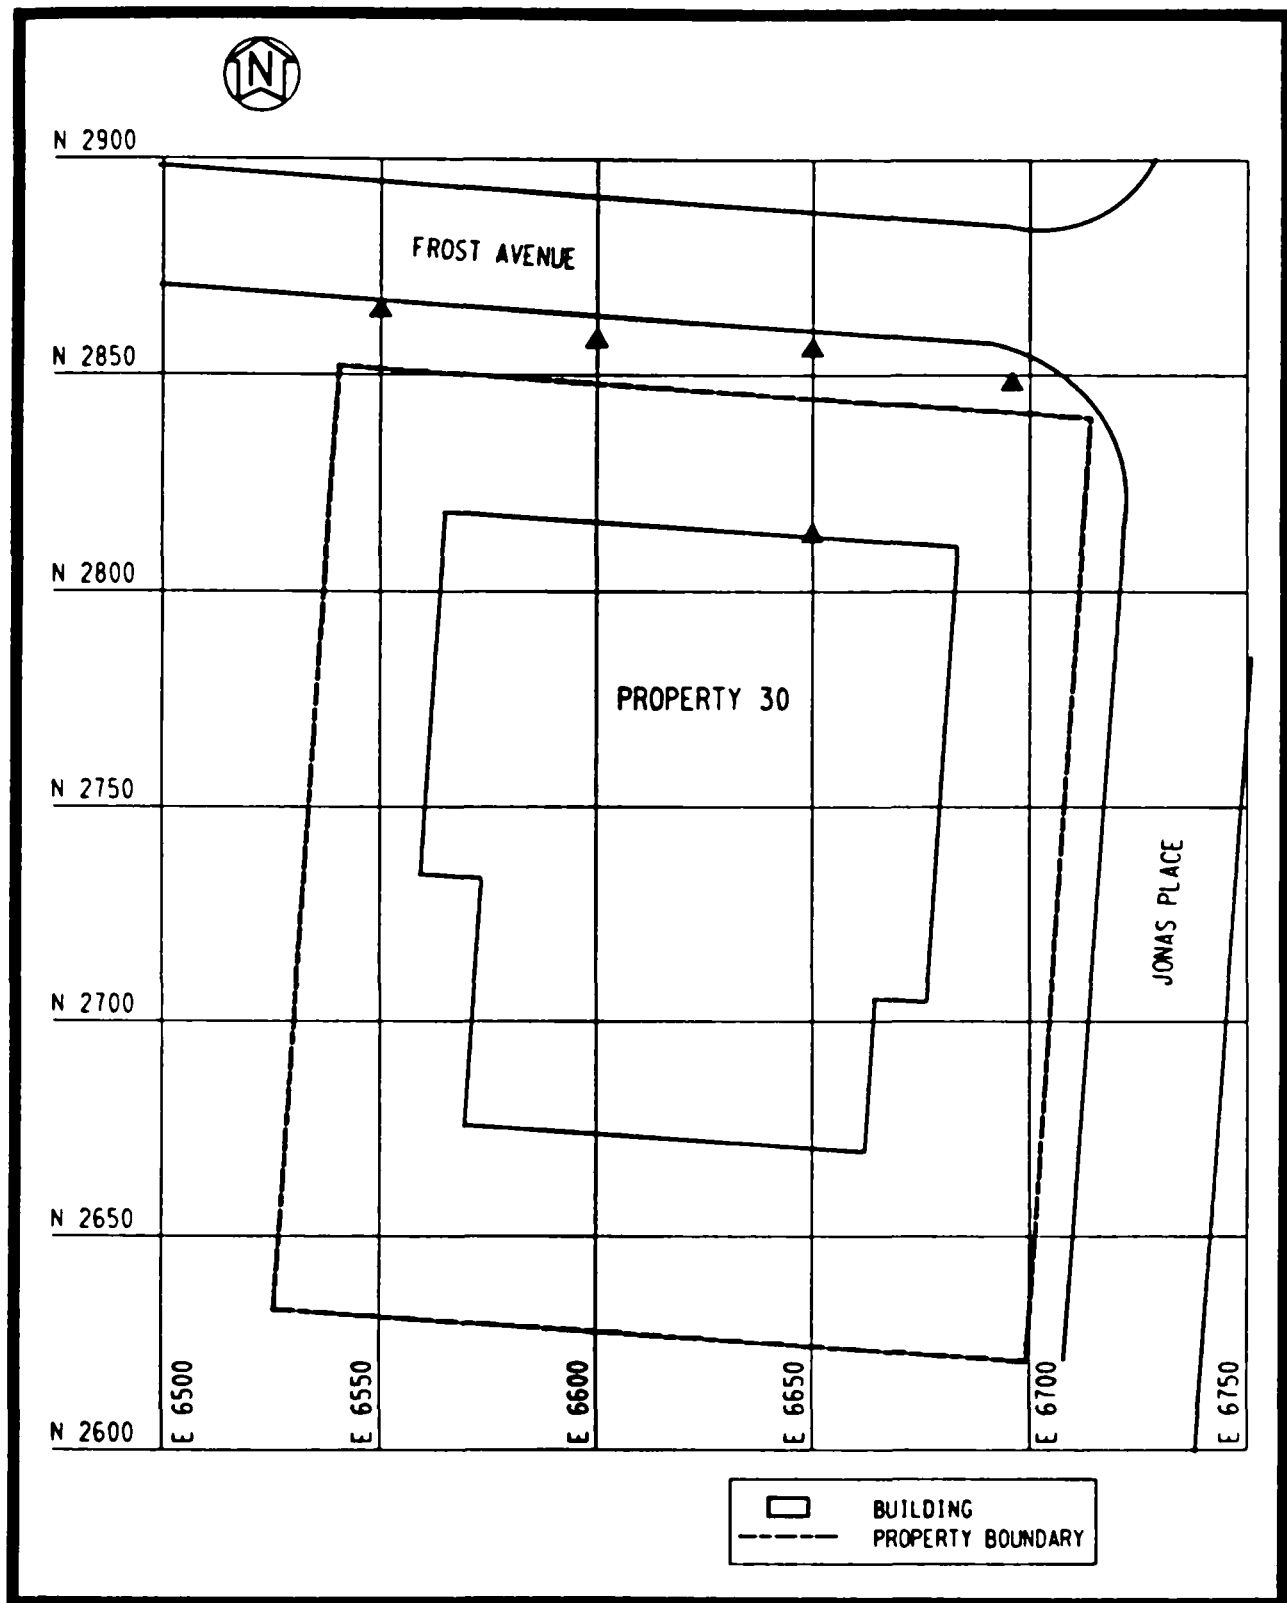
FIGURE 5-61 SOIL SAMPLING LOCATIONS FOR RADIOLOGICAL CHARACTERIZATION OF HAUL ROADS VICINITY PROPERTY 30

Property 30 is located on the corner at the intersection of Frost Avenue and Jonas Place. Soil sampling locations at this property are shown in Figure 5-61. Analytical results for soil (Table 5-38) revealed one sampling location with an elevated concentration of thorium-230. Thorium-230 concentrations ranged from 1 to 8.8 pCi/g. Areas and depths of radioactive contamination at Property 30 are shown in Figure 5-62.

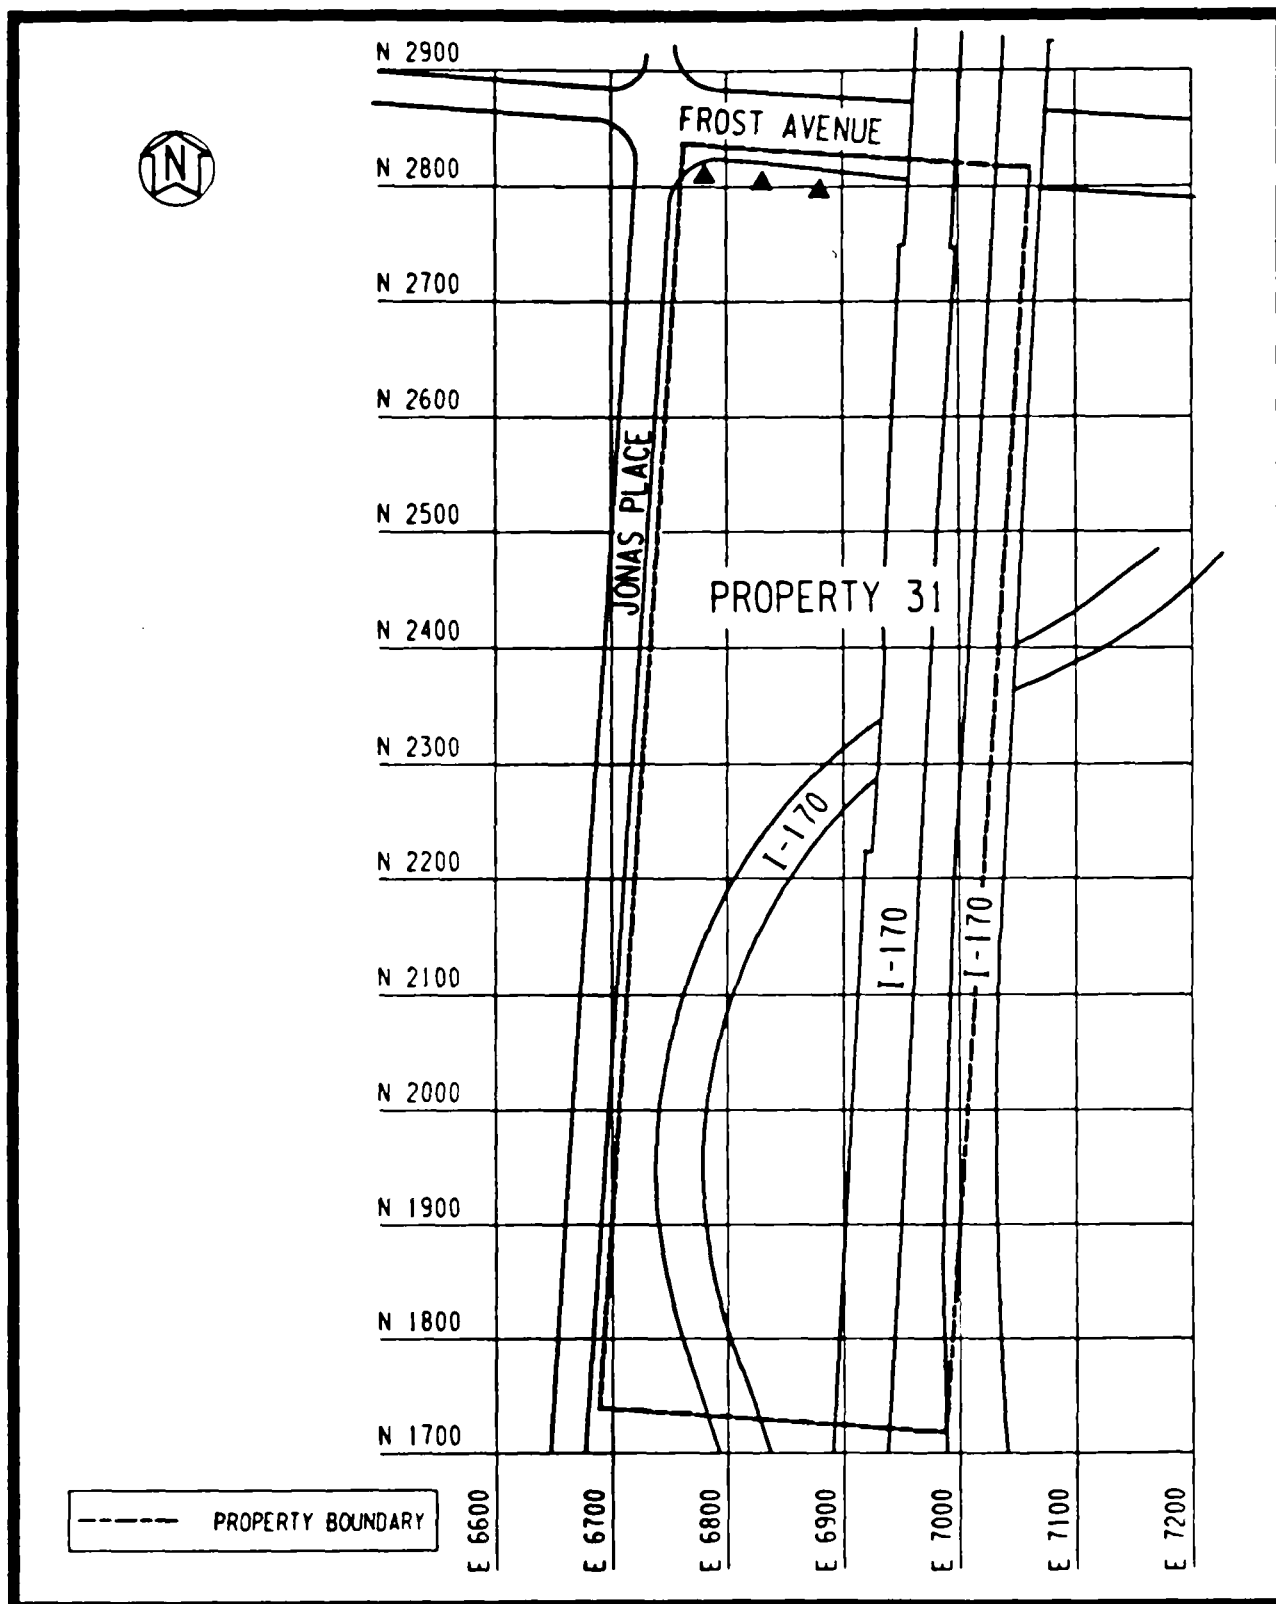
FIGURE 5-63 SOIL SAMPLING LOCATIONS FOR RADIOLOGICAL CHARACTERIZATION OF HAUL ROADS VICINITY PROPERTY 31

Property 31 is located on Frost Avenue east of Jonas Place. Locations from which soil samples were collected and analyzed from the road's edge adjacent to Property 31 are shown in Figure 5-63. None of the samples exhibited elevated levels of thorium-230. Thorium-230 concentrations ranged from 1.2 to 2.1 pCi/g. Analytical results for soil are provided in Table 5-39.

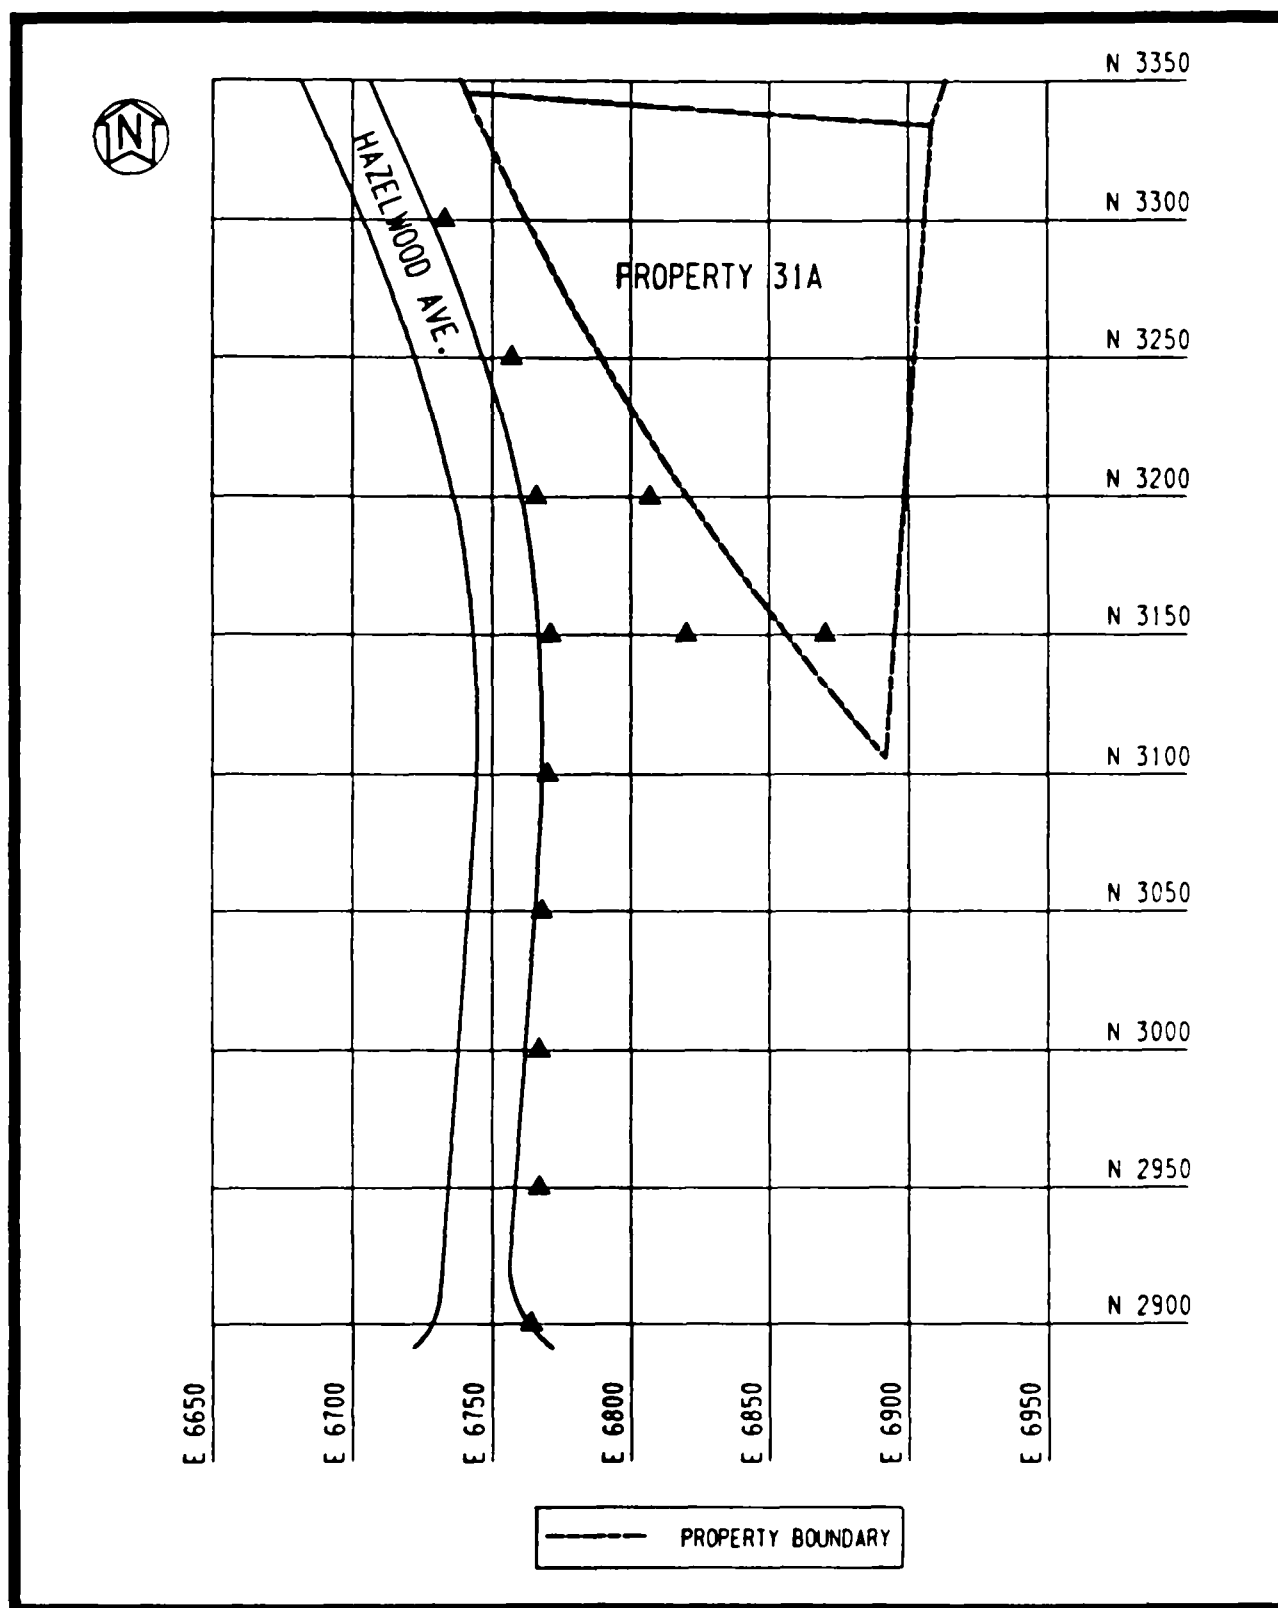
FIGURE 5-64 SOIL SAMPLING LOCATIONS FOR RADIOLOGICAL CHARACTERIZATION OF HAUL ROADS VICINITY PROPERTY 31A

Property 31A is located on Hazelwood Avenue. Locations from which soil samples were collected and analyzed adjacent to this property are shown in Figure 5-64. Analytical results for soil (Table 5-40) revealed three sampling locations with elevated concentrations of thorium-230, which ranged from less than 1 to 41 pCi/g. Before remedial action begins, additional soil samples will be collected from the property to better define the boundaries of radioactive contamination.
